Hong Kong Offshore LNG Terminal Project

Quarterly Environmental Monitoring and Audit (EM&A) Summary Report for April to June 2021

20 August 2021

Project No.: 0505354

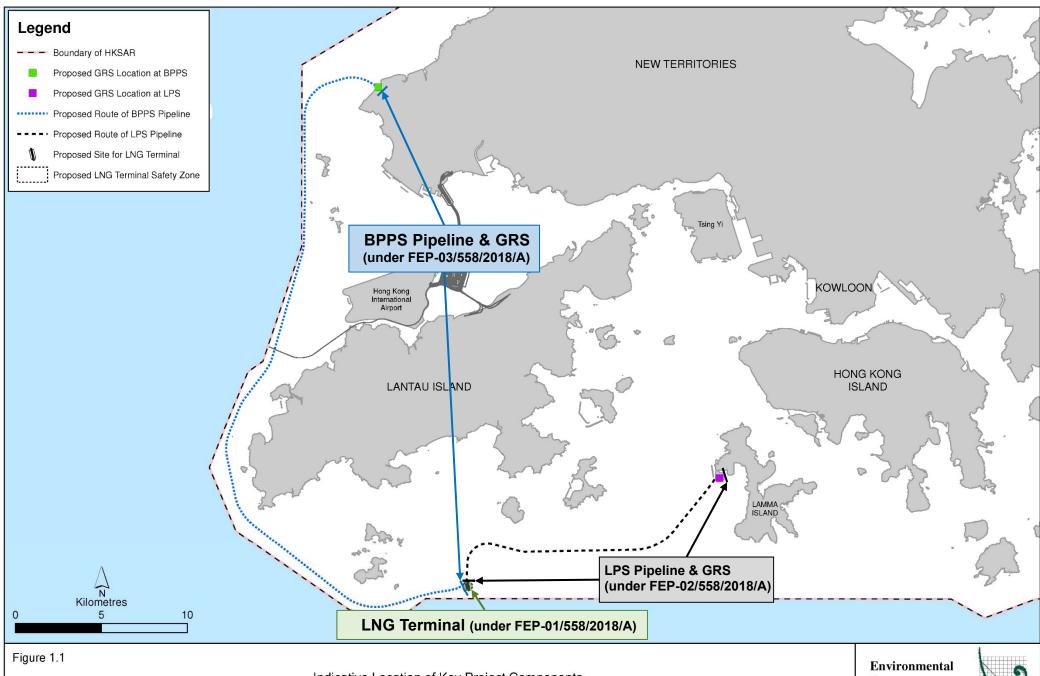
Indicative Location of Key Project Components

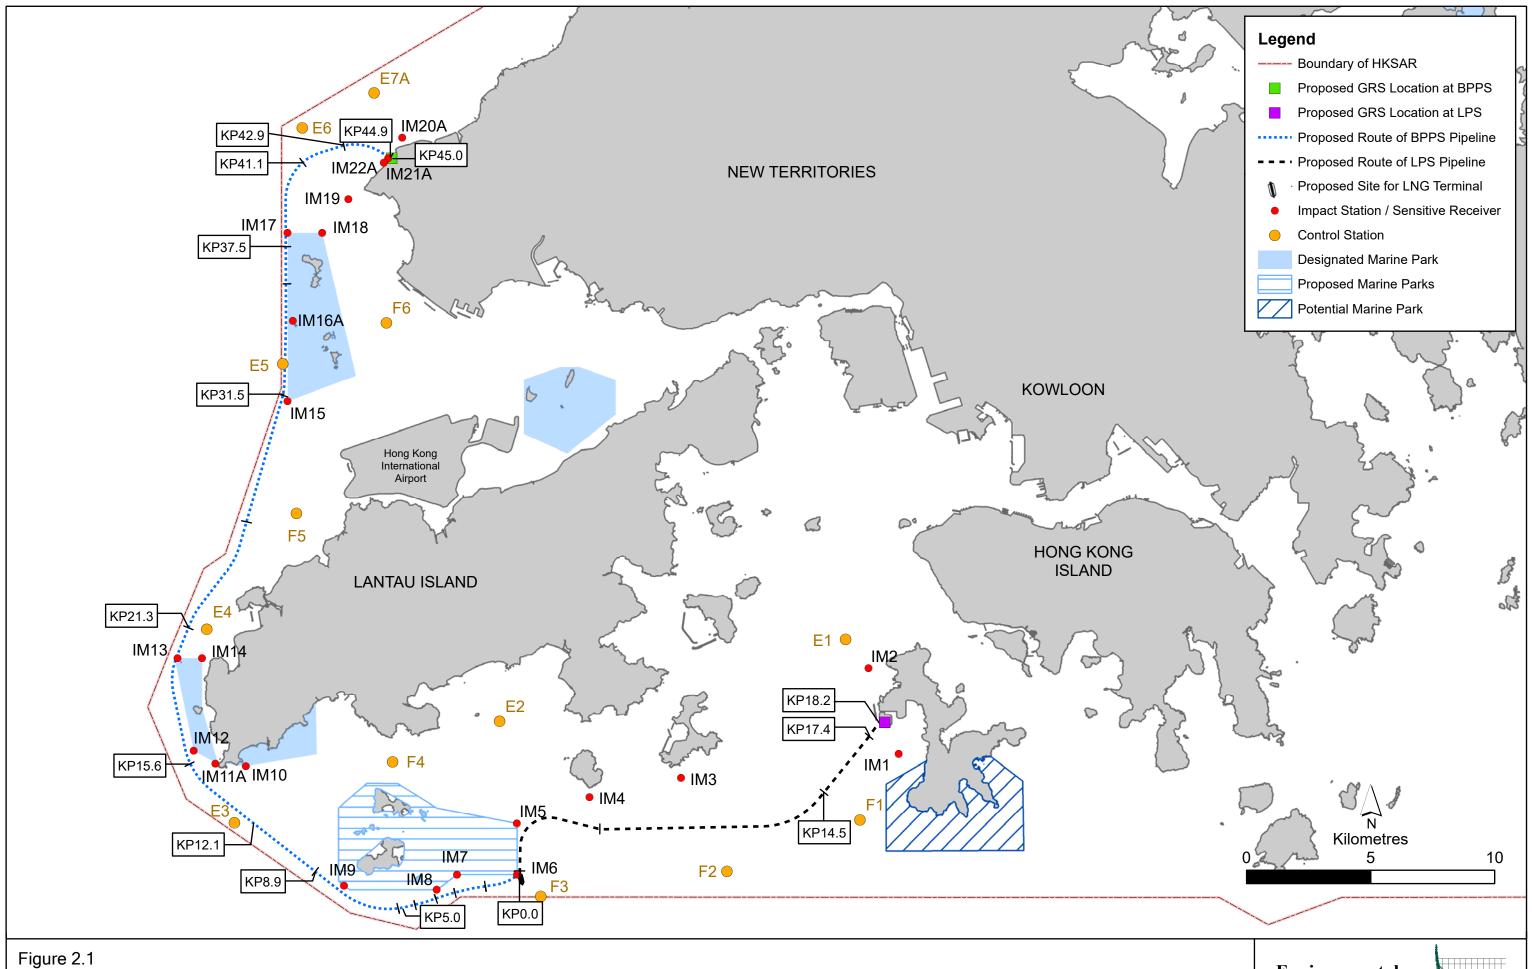
Marine Water Quality Monitoring Location

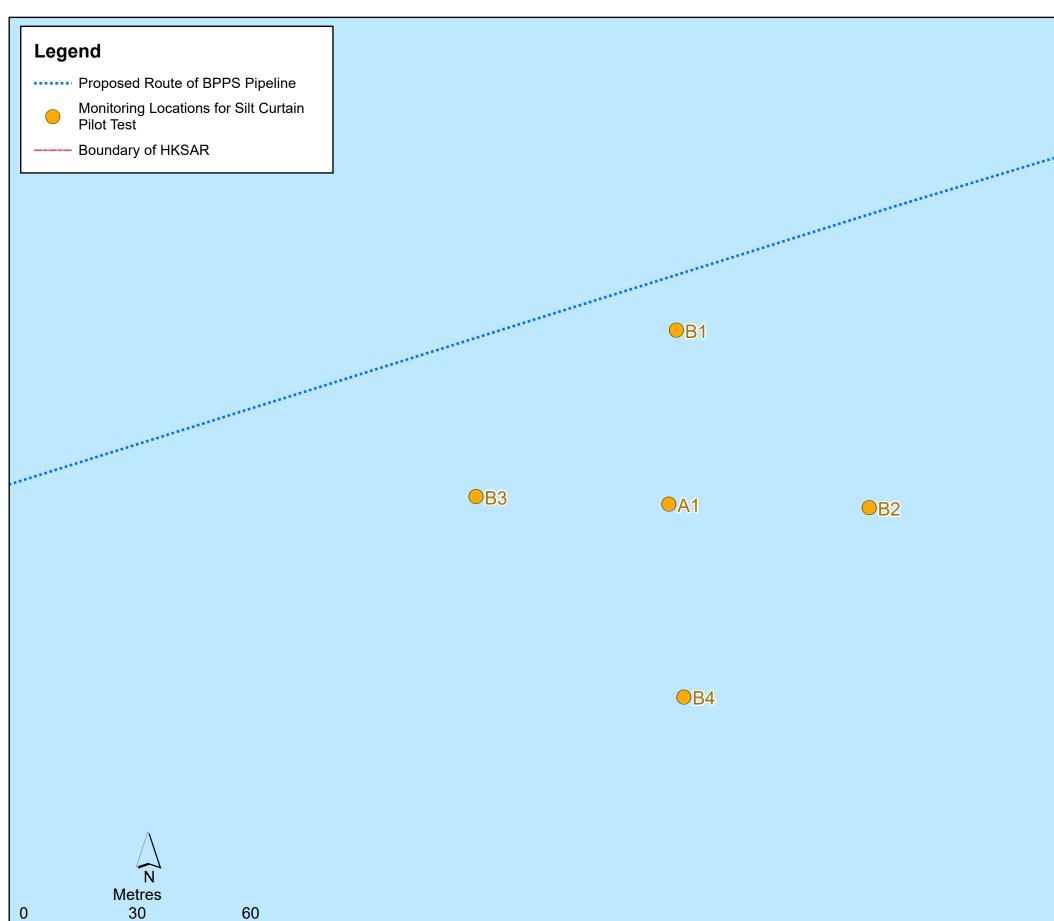
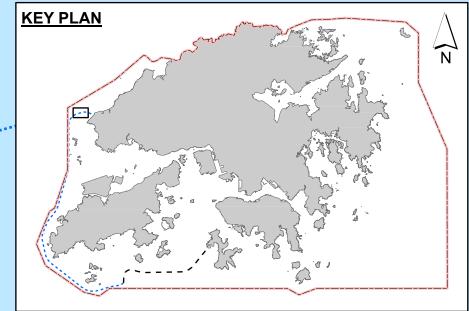
Figure 2.2

Pilot test on the efficiency of cage-type silt curtain at grab dredger was conducted on 7 June 2021. Three rounds of monitoring (i.e. Rounds 1, 2 & 3) for the pilot test covering ebb and flood tides were conducted when dredging operation was operated at or close to the maximum productivity for BPPS Pipeline. The dredging work rate for the three rounds of monitoring ranged from 53.57 – 247.33 m³/hr, which is equivalent to 1,286 – 5,936 m³/day for 24 hours work. The monitoring stations for the pilot test are presented in *Figure 2.2*.

Coordinates of Monitoring Stations						
Position	Easting	Northing				
A1	806851	831284				
B1	806853	831330				
B2	806904	831283				
В3	806800	831286				
B4	806855	831233

The results of the pilot test have demonstrated that the tested cage-type silt curtain for dredging operation is capable of achieving an efficiency greater than 75% as assumed in the approved EIA Report for the HKOLNG Terminal project. As such, the proposed cage-type silt curtain is effective for the dredging operation for the Project to minimize water quality impacts and no further measures/recommendations are required. The detailed monitoring results can be referred to Section 2.4 of the Monthly EM&A Report for June 2021.

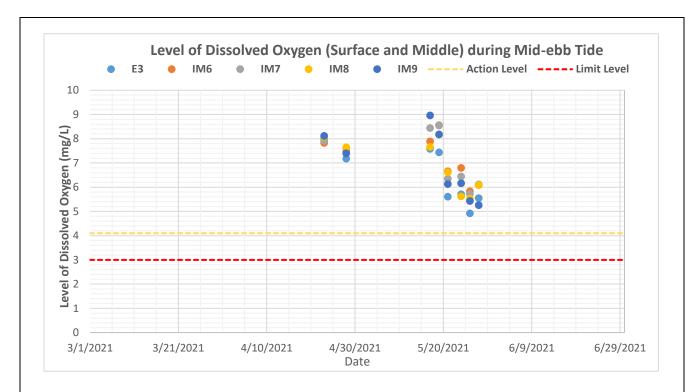
Figure F1a: Levels of Surface and Middle Dissolved Oxygen (mg/L) at control station (E3) and impact stations (IM6-IM9) under Group 3 during mid-ebb tides in the past four months (i.e. March to June 2021).

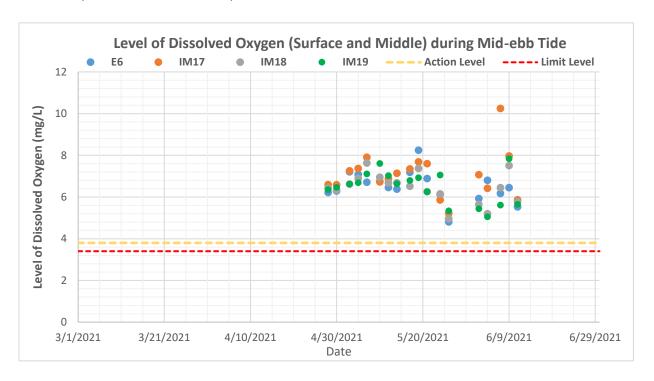
Figure F1b: Levels of Surface and Middle Dissolved Oxygen (mg/L) at control station (E6) and impact stations (IM17-IM19) under Group 7 during mid-ebb tides in the past four months (i.e. March to June 2021).

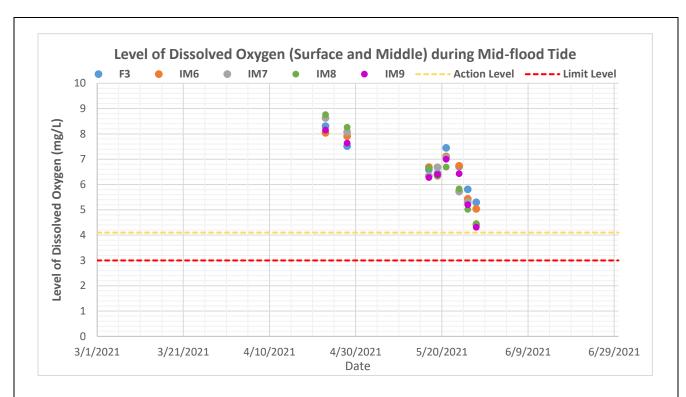
Figure F1c: Levels of Surface and Middle Dissolved Oxygen (mg/L) at control station (F3) and impact stations (IM6-IM9) under Group 3 during mid-flood tides in the past four months (i.e. March to June 2021).

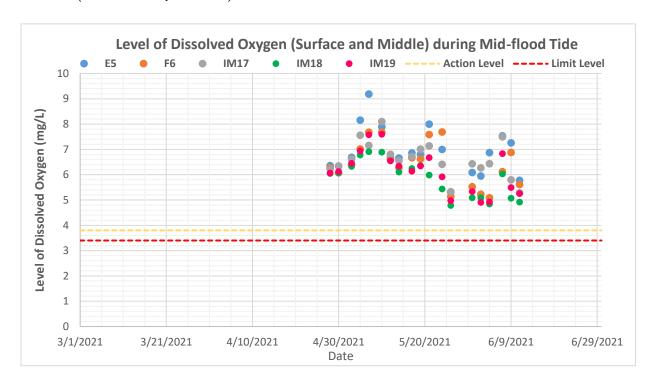
Figure F1d: Levels of Surface and Middle Dissolved Oxygen (mg/L) at control stations (E5, F6) and impact stations (IM17-IM19) under Group 7 during mid-flood tides in the past four months (i.e. March to June 2021).

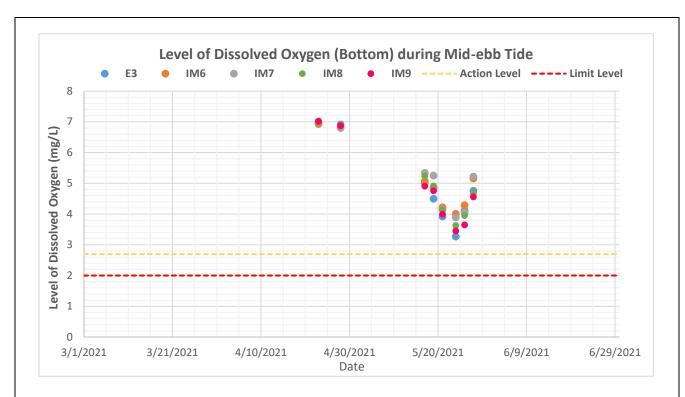
Figure F2a: Levels of Bottom Dissolved Oxygen (mg/L) at control station (E3) and impact stations (IM6-IM9) under Group 3 during mid-ebb tides in the past four months (i.e. March to June 2021).

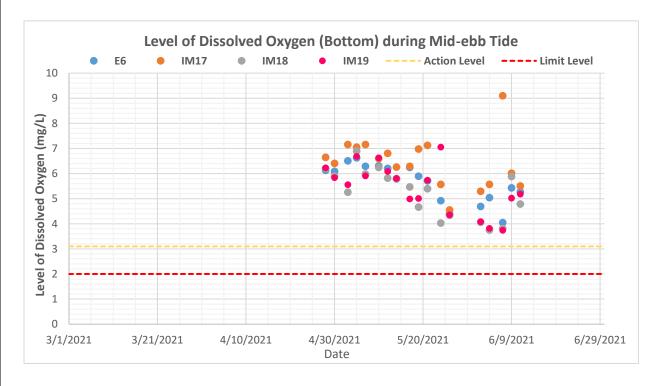
Figure F2b: Levels of Bottom Dissolved Oxygen (mg/L) at control station (E6) and impact stations (IM17-IM19) under Group 7 during mid-ebb tides in the past four months (i.e. March to June 2021).

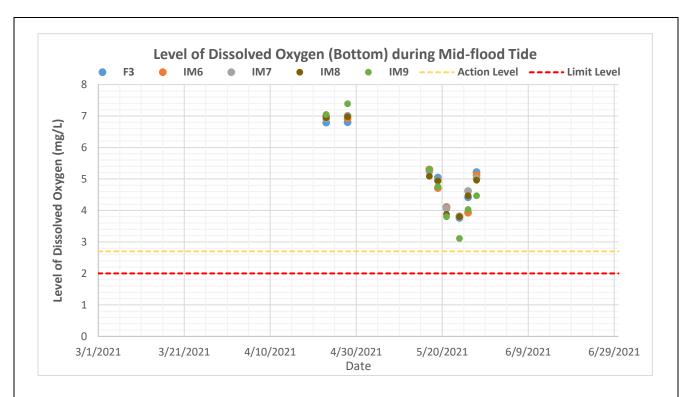
Figure F2c: Levels of Bottom Dissolved Oxygen (mg/L) at control station (F3) and impact stations (IM6-IM9) under Group 3 during mid-flood tides in the past four months (i.e. March to June 2021).

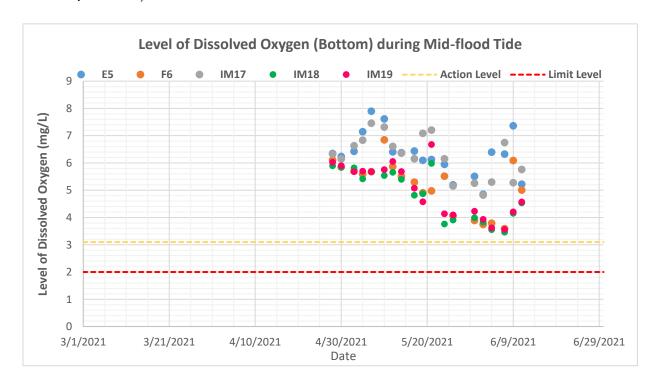
Figure F2d: Levels of Bottom Dissolved Oxygen (mg/L) at control stations (E5, F6) and impact stations (IM17-IM19) under Group 7 during mid-flood tides in the past four months (i.e. March to June 2021).

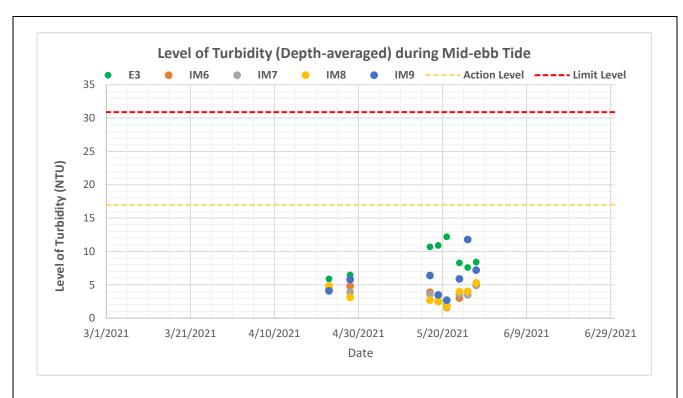
Figure F3a: Levels of Depth-averaged Turbidity (NTU) at control station (E3) and impact stations (IM6-IM9) under Group 3 during mid-ebb tides in the past four months (i.e. March to June 2021).

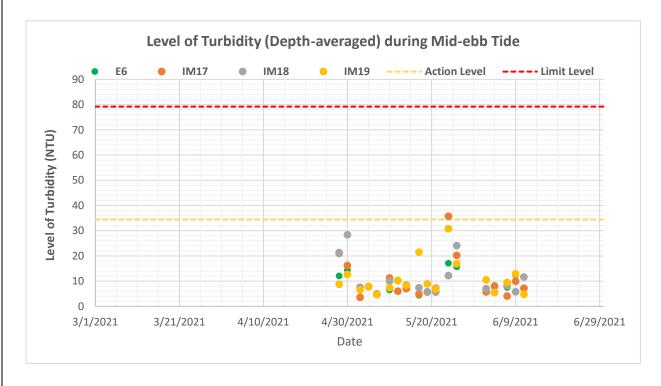
Figure F3b: Levels of Depth-averaged Turbidity (NTU) at control station (E6) and impact stations (IM17-IM19) under Group 7 during mid-ebb tides in the past four months (i.e. March to June 2021).

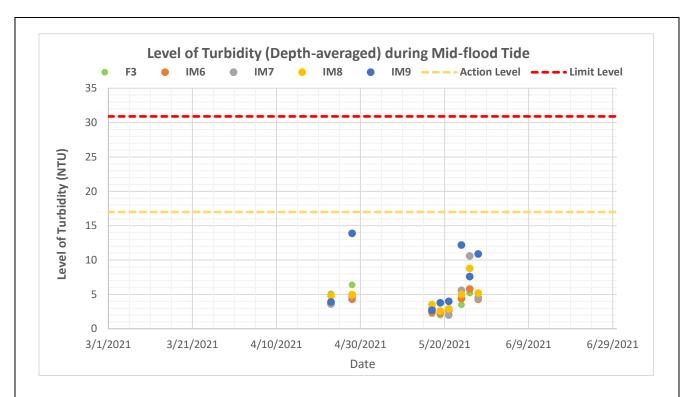
Figure F3c: Levels of Depth-averaged Turbidity (NTU) at control station (F3) and impact stations (IM6-IM9) under Group 3 during mid-flood tides in the past four months (i.e. March to June 2021).

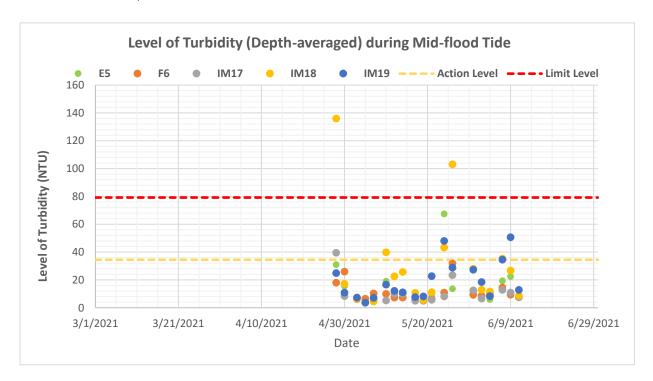
Figure F3d: Levels of Depth-averaged Turbidity (NTU) at control stations (E5, F6) and impact stations (IM17-IM19) under Group 7 during mid-flood tides in the past four months (i.e. March to June 2021).

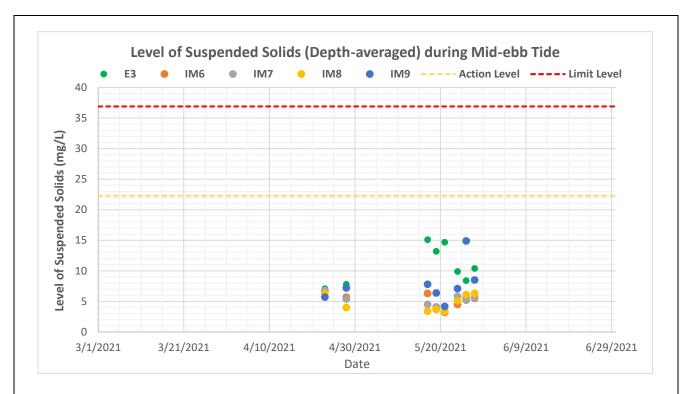
Figure F4a: Levels of Depth-averaged Suspended Solids (mg/L) at control station (E3) and impact stations (IM6-IM9) under Group 3 during mid-ebb tides in the past four months (i.e. March to June 2021).

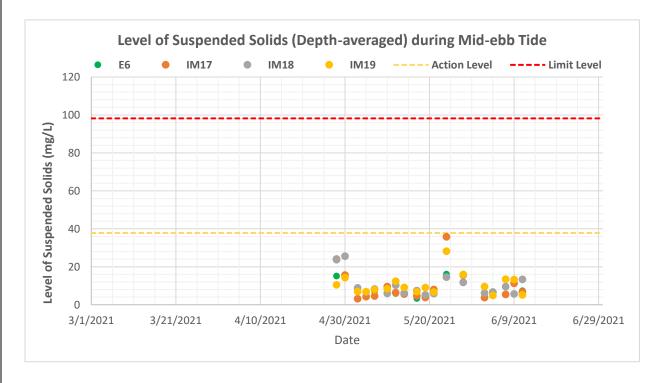
Figure F4b: Levels of Depth-averaged Suspended Solids (mg/L) at control station (E6) and impact stations (IM17-IM19) under Group 7 during mid-ebb tides in the past four months (i.e. March to June 2021).

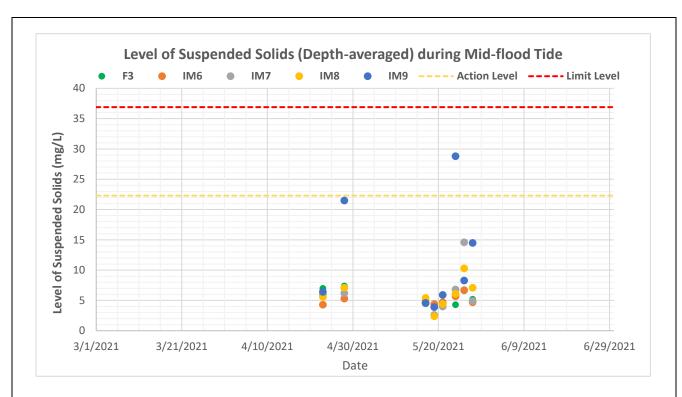
Figure F4c: Levels of Depth-averaged Suspended Solids (mg/L) at control station (F3) and impact stations (IM6-IM9) under Group 3 during mid-flood tides in the past four months (i.e. March to June 2021).

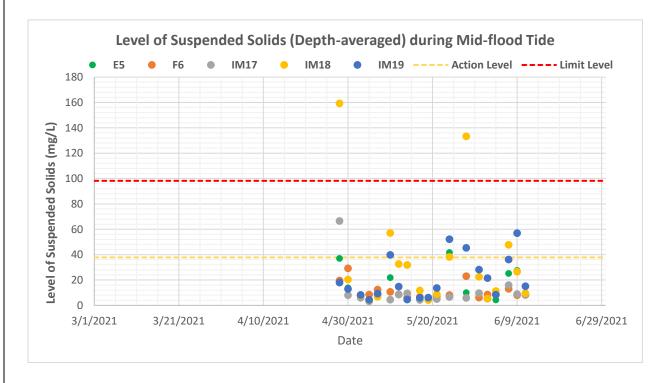
Figure F4d: Levels of Depth-averaged Suspended Solids (mg/L) at control stations (E5, F6) and impact stations (IM17-IM19) under Group 7 during mid-flood tides in the past four months (i.e. March to June 2021).
