Hong Kong Offshore LNG Terminal Project

Quarterly Environmental Monitoring and Audit (EM&A) Summary Report for January to March 2022

23 May 2022

Project No.: 0505354

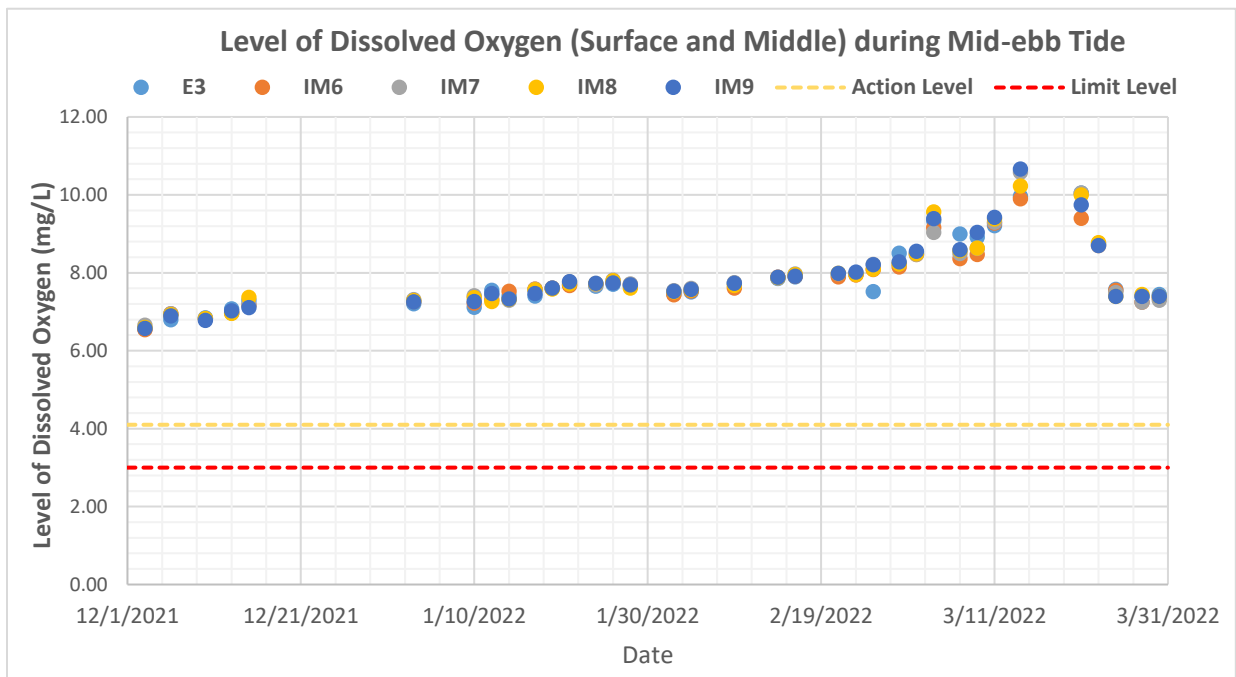
Figure F1b: Levels of Surface and Middle Dissolved Oxygen (mg/L) at control station (E3) and impact stations (IM6-IM9) under Group 3 during mid-ebb tides in the past four months (i.e. December 2021 to March 2022)

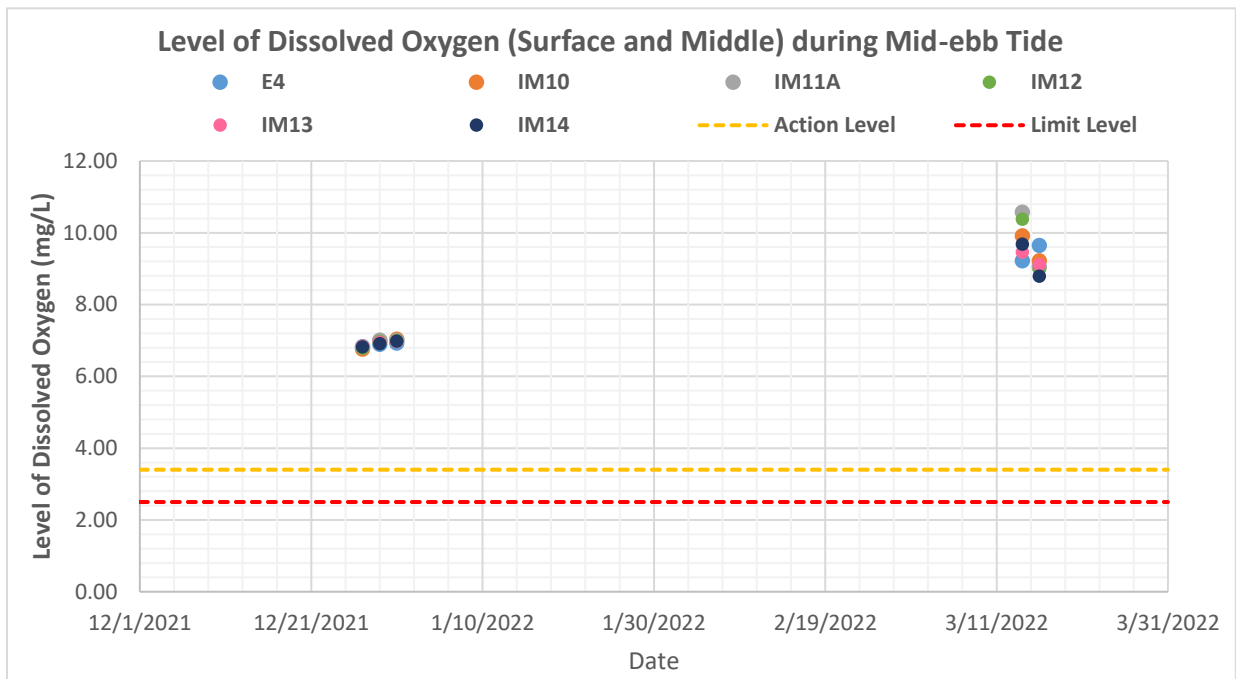
Figure F1c: Levels of Surface and Middle Dissolved Oxygen (mg/L) at control station (E4) and impact stations (IM10-IM14) under Group 4 during mid-ebb tides in the past four months (i.e. December 2021 to March 2022)

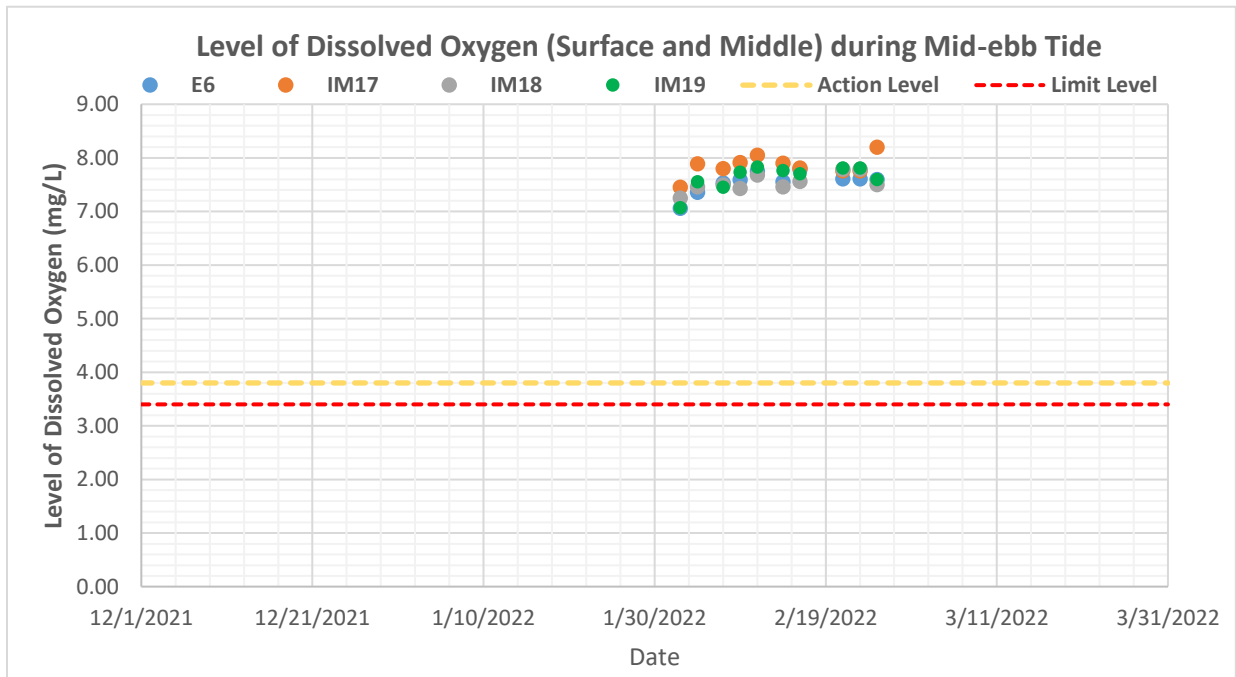
Figure F1f: Levels of Surface and Middle Dissolved Oxygen (mg/L) at control station (E6) and impact stations (IM17-IM19) under Group 7 during mid-ebb tides in the past four months (i.e. December 2021 to March 2022)
